Residential Product Info: www.period-homes.com PROJECT: Exterior Renovations & Interiors of Colonial Revival Home, Riverside, Conn.

ARCHITECT: Hilton-VanderHorn Architects, Greenwich, Conn.

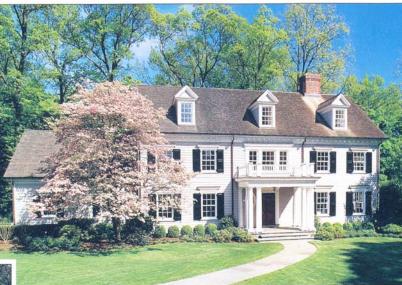
Front elevation before (left). The elients were looking for a bouse with stature and classical details, but when they came up short, they refocused their quest for an existing bome with potential. This Riverside, Conn., 1960s spec bouse with its unseemly stick columned front, lonely front door, and undefined roof inspired Hilton-VanderHorn Architects and their clients to re-create a bouse with real presence.

After (above). The renovated elevation provides a very different scene. The majority of the project scope was to re-create the exterior beginning with the roof, which was removed and raised to make room for a cornice. The pitch was also increased to create a more substantial third foor that was further defined by the addition of dorner windows and an extended brick chimney. The windows were repositioned and the classically referenced portico completed the new face. Landscaping by Peter Grunow of GroPro Landscaping, Greenwich, Conn., complements the new elevation with a welcoming stone walkway and new plantings.

The exterior cornices were based on classical precedents using the Architectural Treasures of America series and the American Vignola as references. For the facade, a five-bay scheme was chosen featuring a new portico with a triple window above, which is flanked by two

pairs of windows to either side. Three new dormers and an extended new brick chimney accent the roof. As a focal point, the portico's columns support an entablature with a modilioned cornice topped by a decorative railing. The new windows with custom casings, head cornices, and paneled shutters further enliven the front elevation.

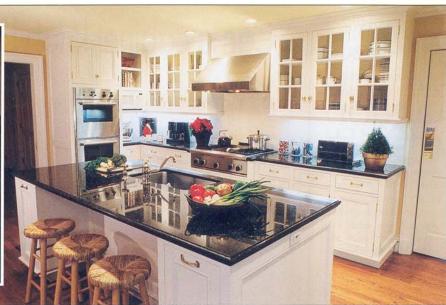
Kitchen before (inset) and after (above). The Kitchen/Breakfast room was rearranged in order to free up the outside back-elevation wall that houses the new breakfast bay. The kitchen work area is directly across from the bay with a work island in between. Custom-made cabinets are traditionally styled with exposed-binge doors and drawers framed by fixed stiles. Granite countertops and glazed upper cabinets complete the cabinetry as built-in furniture.

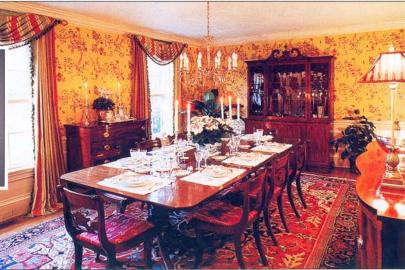
Dining room before (above) and after (right). The Before shot shows the existing room that featured a hay oddly placed to one side of the space. The renovated and decorated room now features two double-hung windows that replace the hay on the front facade and evenly distribute and modulate incoming light, as well as allow for a more-comfortable furniture plan. A new cornice, paneled wainscot, and base provide the details needed to add scale and intimacy to the room.
